DEVELOPMENT OF PROTECTIVE COATINGS FOR CHROMIUM-BASE ALLOYS

NATIONAL AERONAUTICS AND SPACE ADMINISTRATION

Contract NAS 3-7612

BATTELLE MEMORIAL INSTITUTE

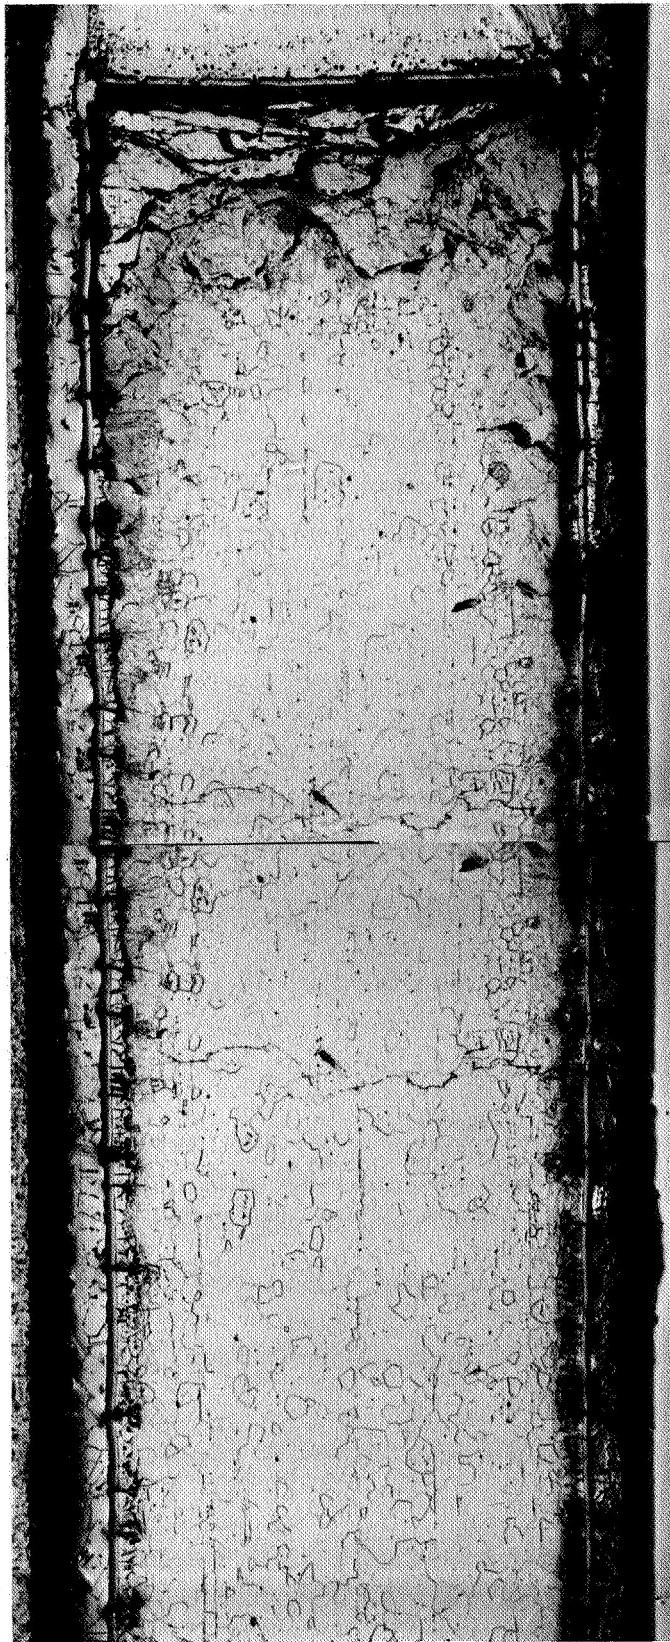
FIGURE 37. NITRIDING IN A SYSTEM 1b SAMPLE
CYCLICALLY OXIDIZED 40 HOURS AT 2300 F
Electrolytic oxalic acid etch.
